Subject: No Further Action Red Horse Trading Post Underground Storage Tank Cleanup Site Red Valley, Arizona (EPA ID No. NAV031)

# ENCLOSURE A RED ROCK TRADING POST UNDERGROUND STORAGE TANK CLEANUP SITE RED VALLEY, ARIZONA (EPA ID NO. NAV31) GPS Coordinates: 36.603901, -109.060747

# ENCLOSURE B Red Rock Trading Post Red Valley, Arizona (EPA ID No. NAV031)

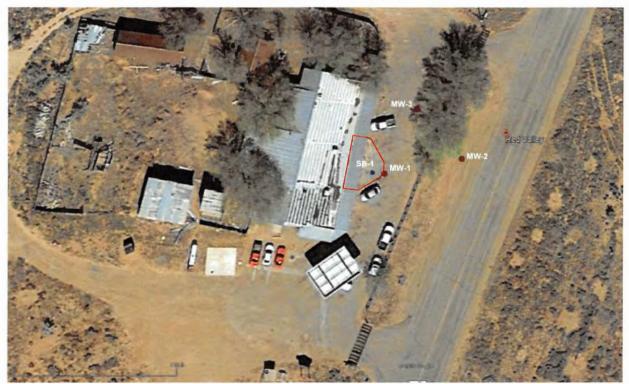
Figure 2: Groundwater monitoring well Locations

EPA contracted through U.S. Army Corp of Engineers for iina' ba', Inc. to assess current groundwater impacts from the 1992 UST removal. Previously gathered information indicated that the generally understood groundwater flow is toward the east/north east in the direction of the Red Rock Wash. Three soil borings were converted into groundwater monitoring wells at the site in June 2016. Water depth was found to be at 20' to 24' bgs.

iina' ba' collected groundwater samples from the three groundwater monitoring wells on June 15, 2016, December 13 2016, and March 2017. The lack of detectable petroleum hydrocarbons in groundwater over the past nine (9) months, (with the exception of a single trace of TPH-DRO) indicates that the former tank basin is no longer a source of petroleum hydrocarbons; and, there appears to be no threat to human health or the environment from the former UST system. All BTEX and MTBE contaminants of concern remain below Navajo Nation's 2012 Groundwater cleanup standards.
